<b>MAINTENANCE &amp; ENGINEERING</b>  <b>FORMS</b>	<b>ENGINE BSI CONDITION REPORT</b>  WORK ORDER. 17989 <b>A/C REG: 5H-PAG.</b> <b>ESN: PCE 120599.</b>
--	---

# 1. GENERAL DATA

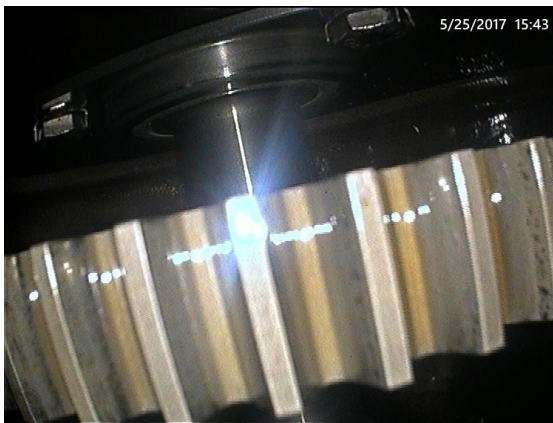
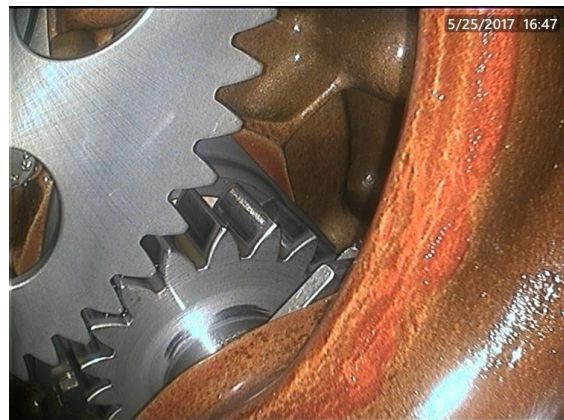
**GEARS CONDITION;** Good condition as per the pictures, could not check pinion gears because is full of preservation oil.

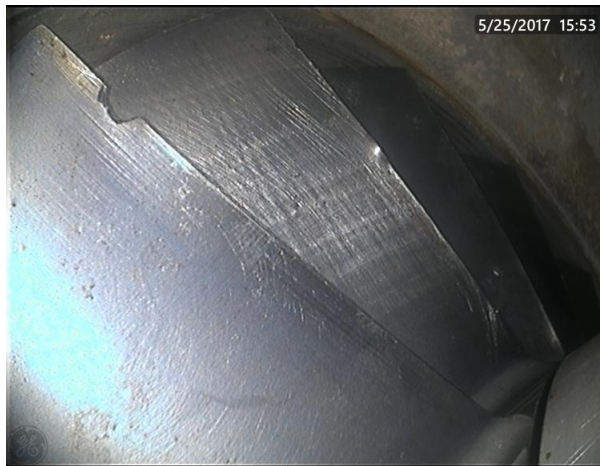
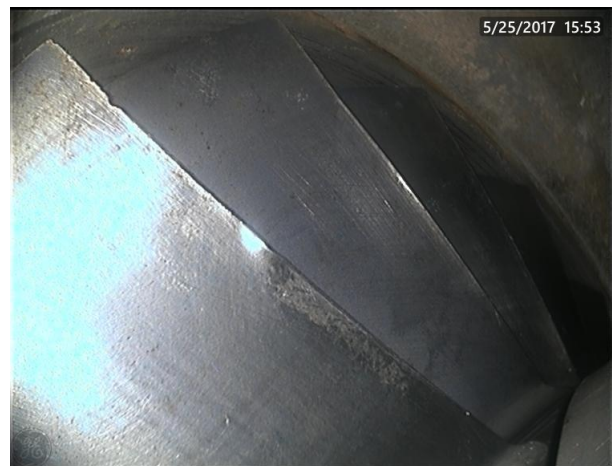
Photos 1 - L.P. impeller condition. good with 3blades with L.E nicks/dents, which requires blending

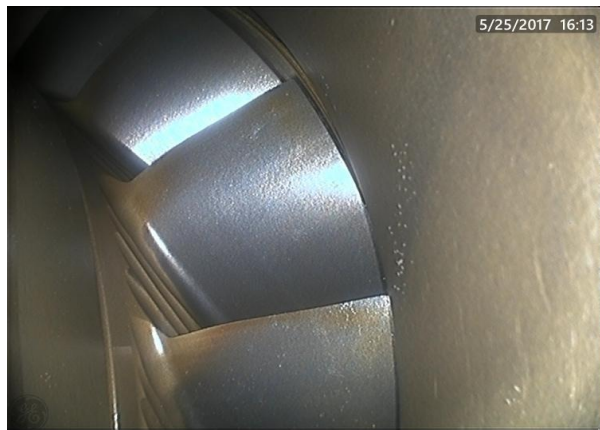
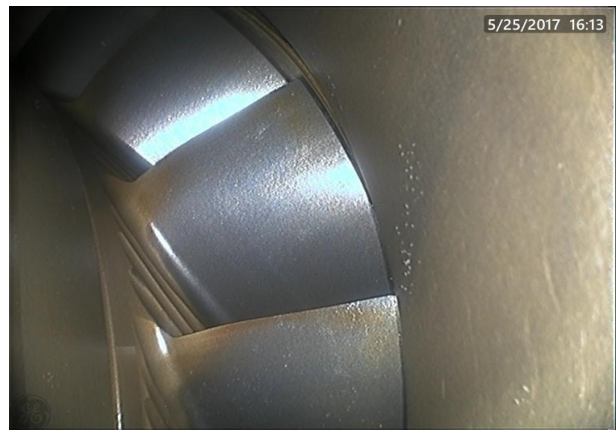
**Photo 1.1 HP impeller Condition is in Good condition**

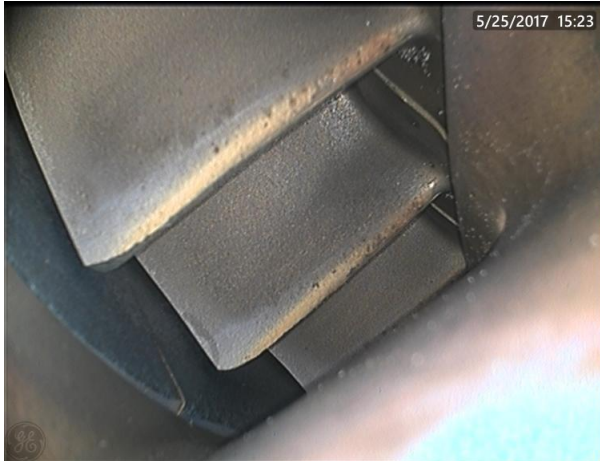
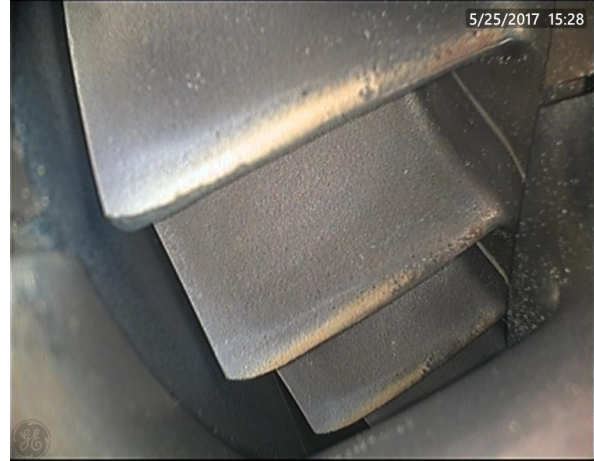
Photos 2 - H.P. turbine blade and shroud segment condition. Good with L.E blade top coating loss, with signs of blade tip rub.

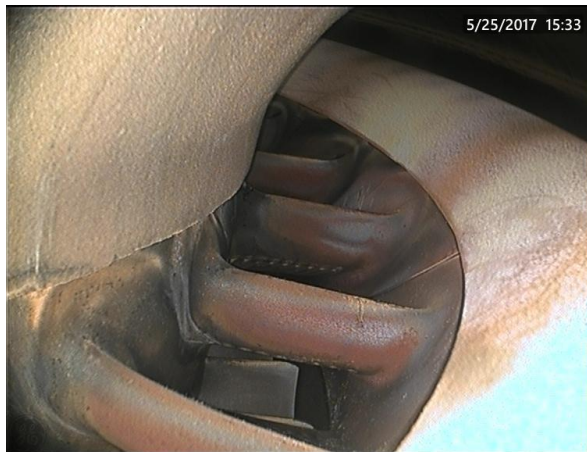
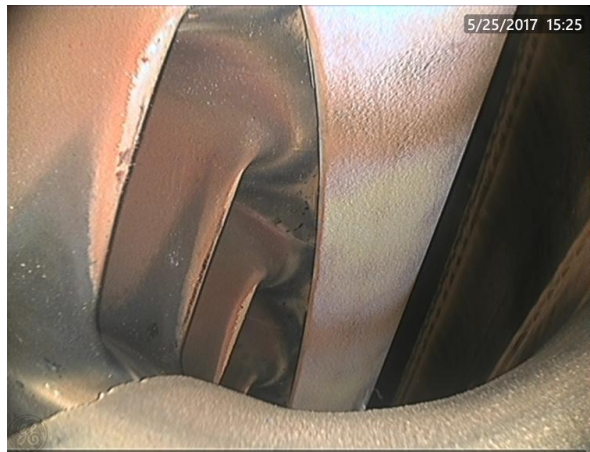
Photos 3 - H.P. triple vane L.E. condition good with normal level of wear

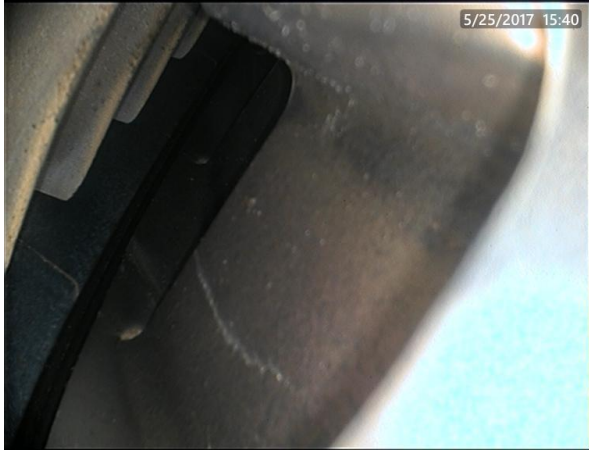
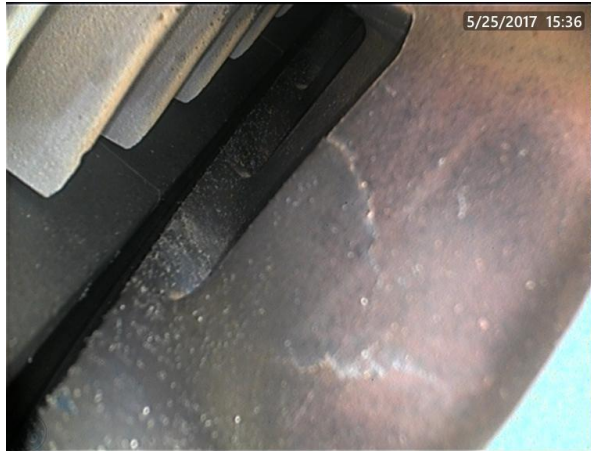
Photos 4 - H.P. triple vane trailing edge condition is good with light cracks as observed

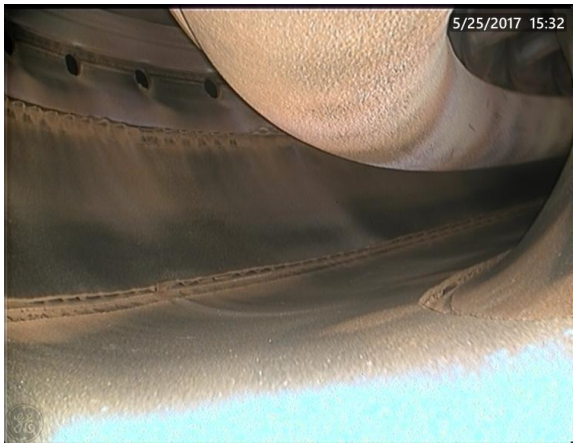
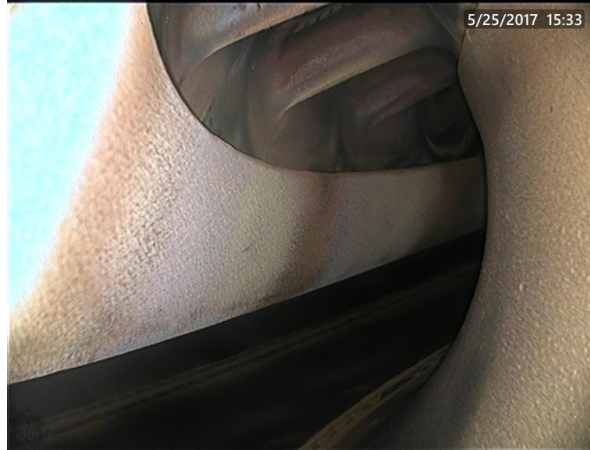
Photos 5 - S.E.D. (Small Exit Duct) condition good with light erosion and burning observed

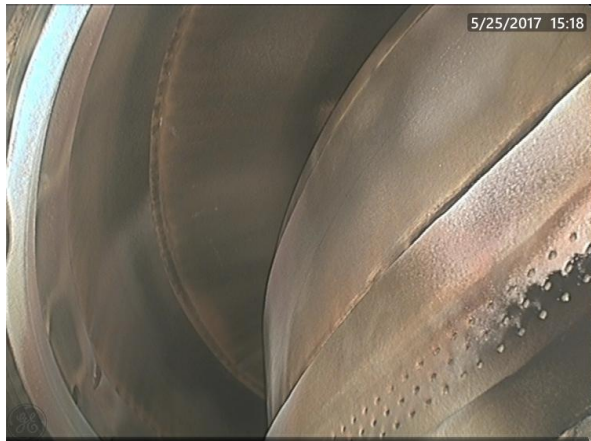
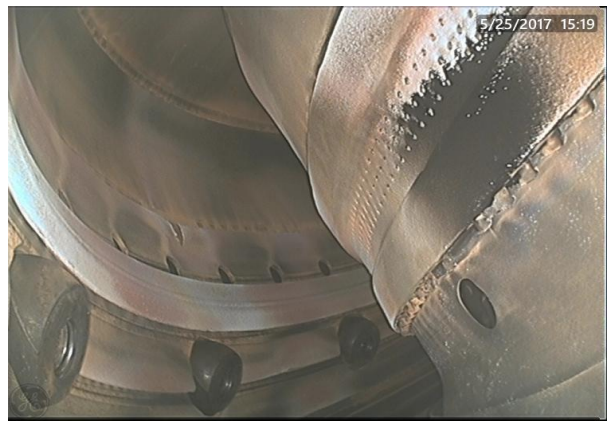
Photos 6 - C.C. liner condition is good with light erosion

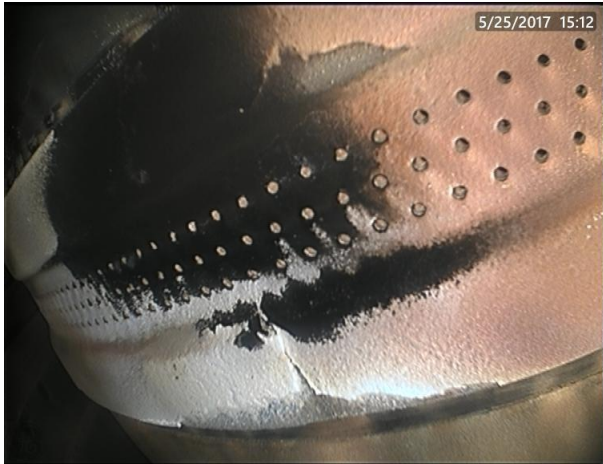
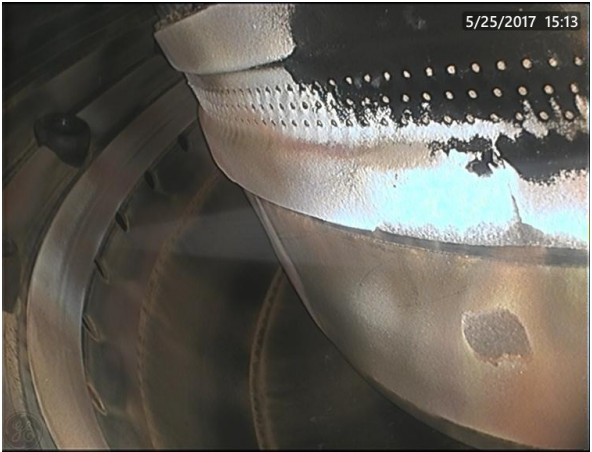
Photos 7 - C.C. liner condition good with some areas with material loss .

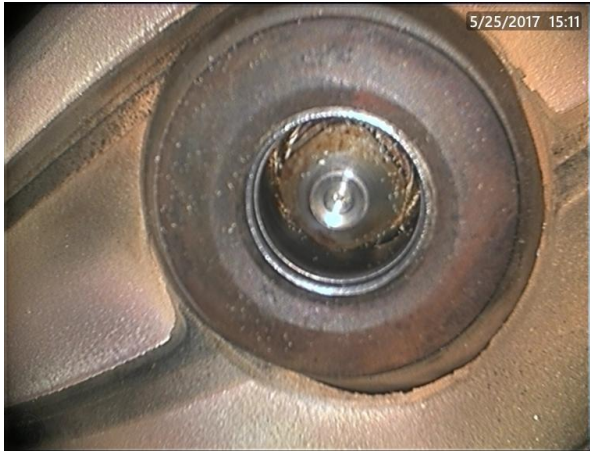
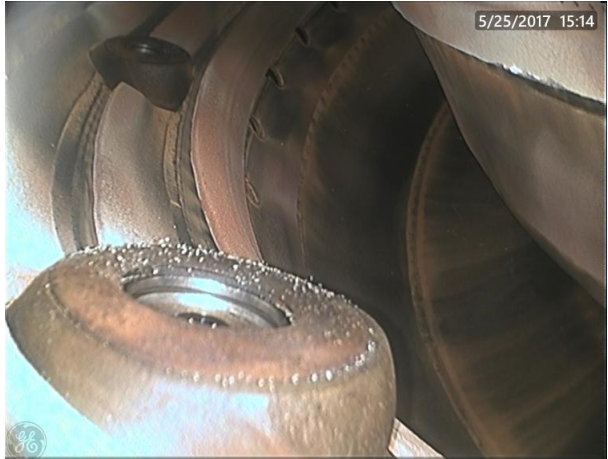
Photos 8 - Fuel nozzle condition good with some giving black carbon in the combustion inner liners.
