<b>MAINTENANCE &amp; ENGINEERING</b>  <b>FORMS</b>	<b>ENGINE BSI CONDITION REPORT</b>  <b>WORK ORDER 17989</b>  <b>A/C REG 5H-PAG...ESN.120578</b>
--	---

## 1. GENERAL DATA

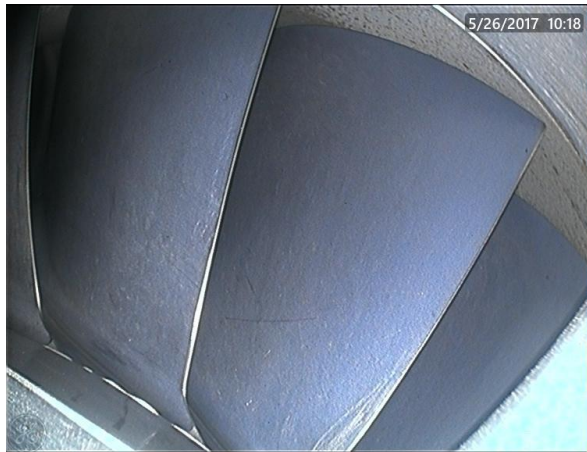
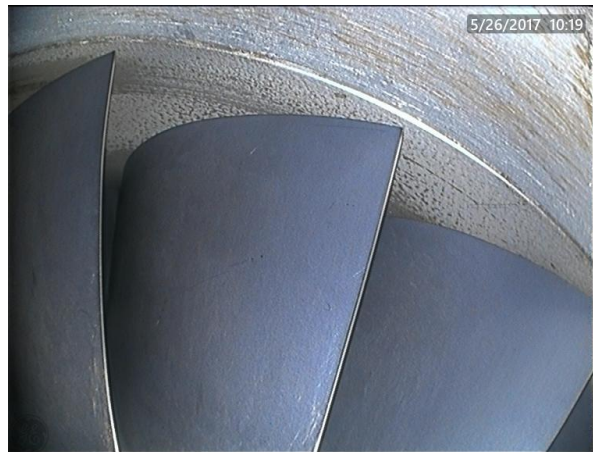
Photos 1 - L.P. impeller condition is good

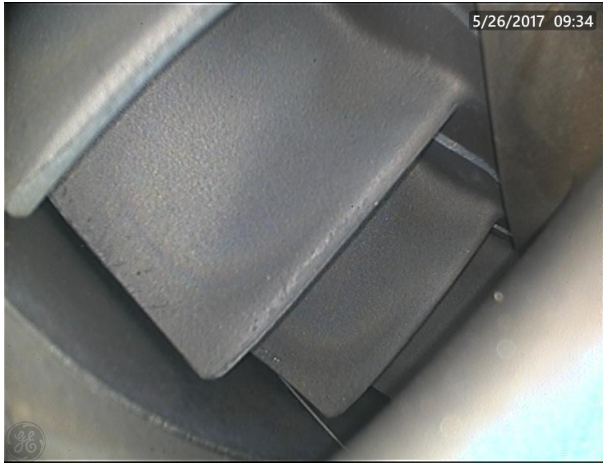
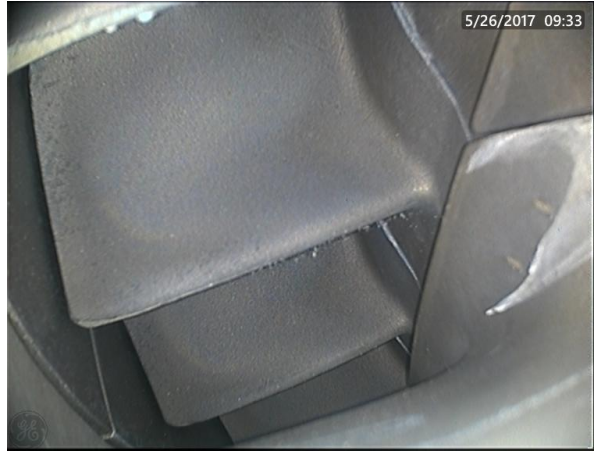
Photos 2 - H.P. turbine blade and shroud segment condition. Is good with L.E Light with cobwebs.

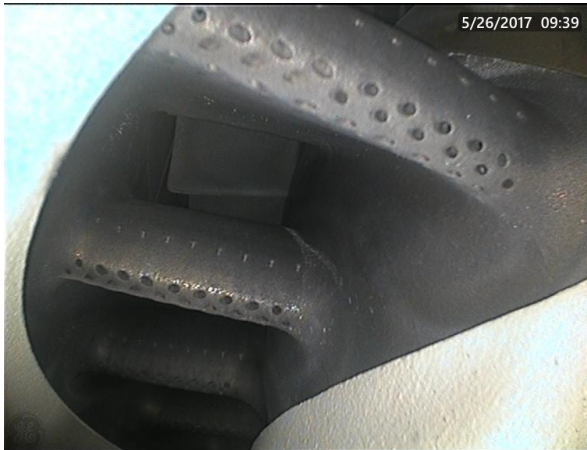
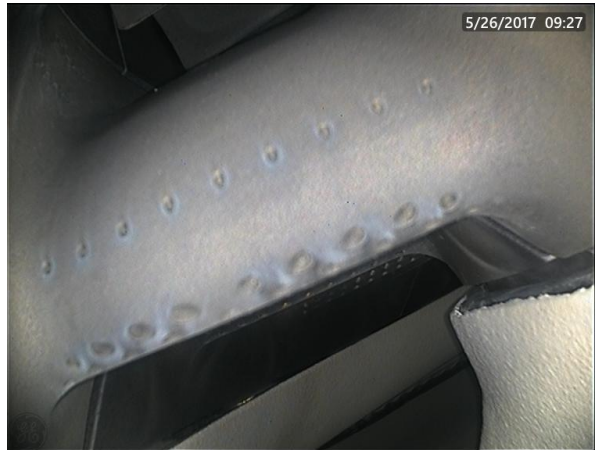
Photos 3 - H.P. triple vane L.E. condition.good

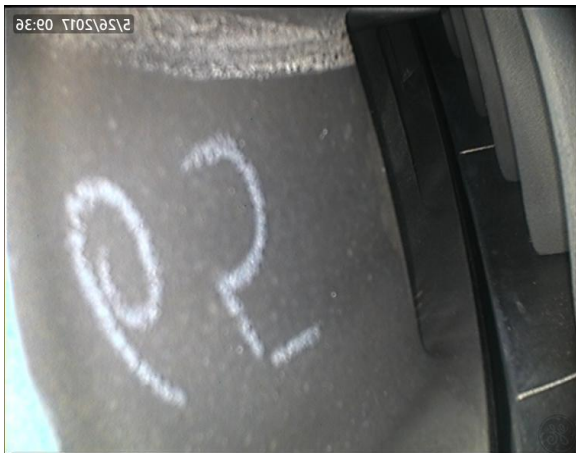
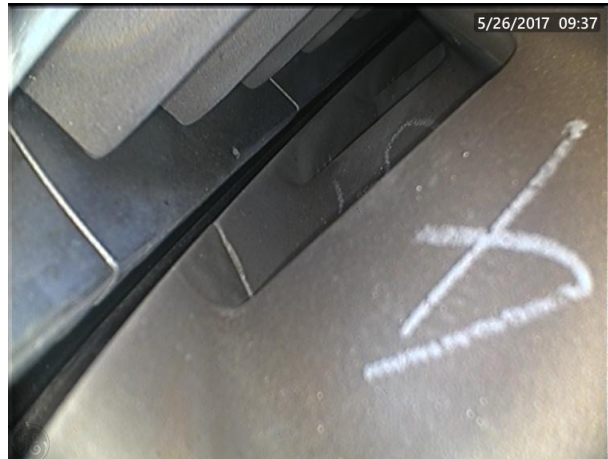
Original Issue Date 31 <sup>st</sup> October, 2014	FORM: <b>PW-TS-1.153 Issue 1 Rev 1</b>	Responsible Manager	Revision Date: August, 2015	Page 3 of 6
		Manager Technical Services

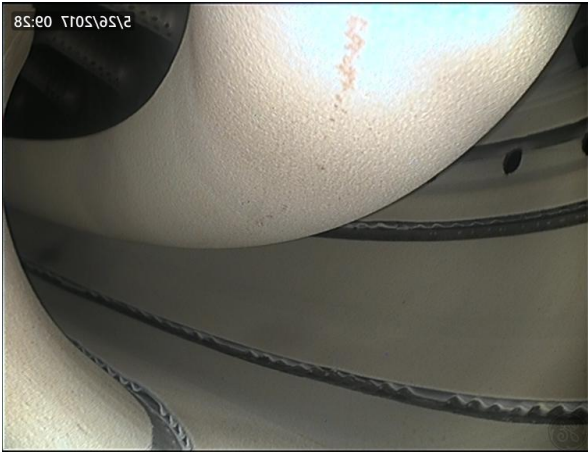
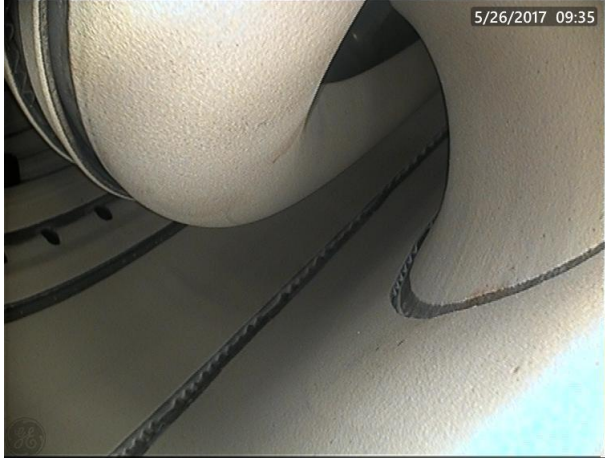
Photos 5 - S.E.D. (Small Exit Duct) condition good,

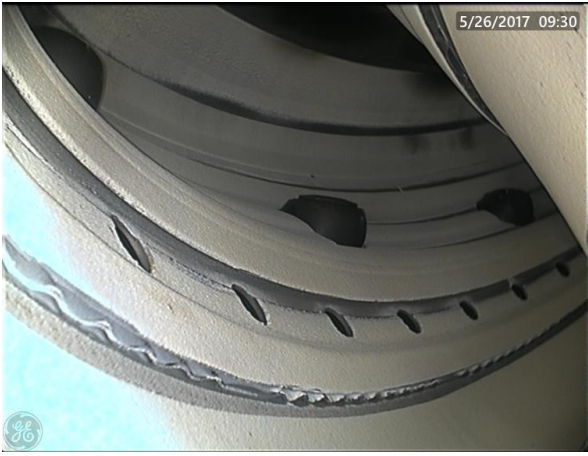
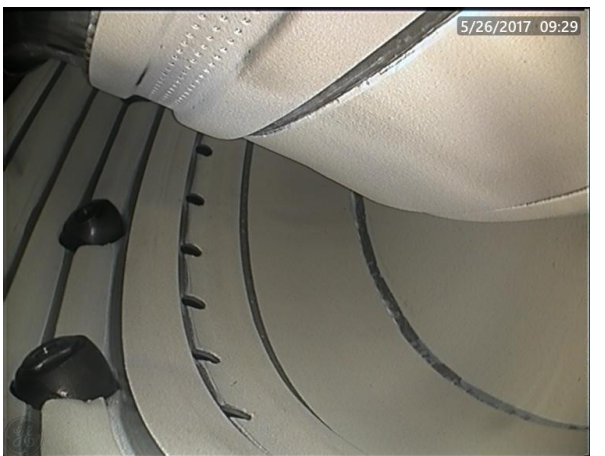
Photos 6 - C.C. liner condition good

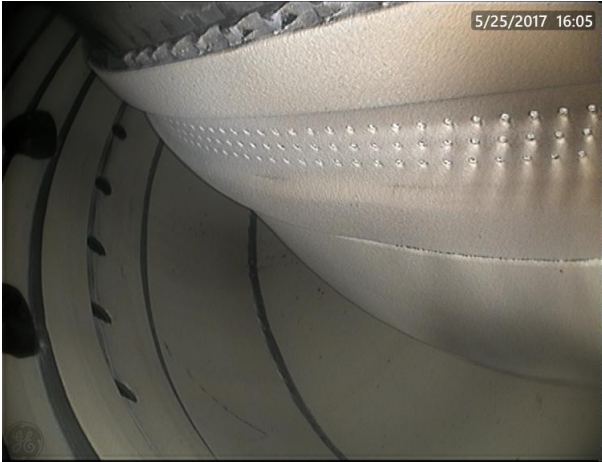
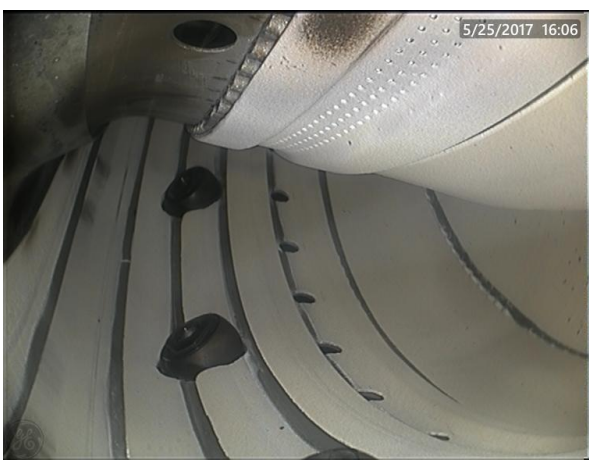
Photos 7 - C.C. liner condition is good with black soot to some area.

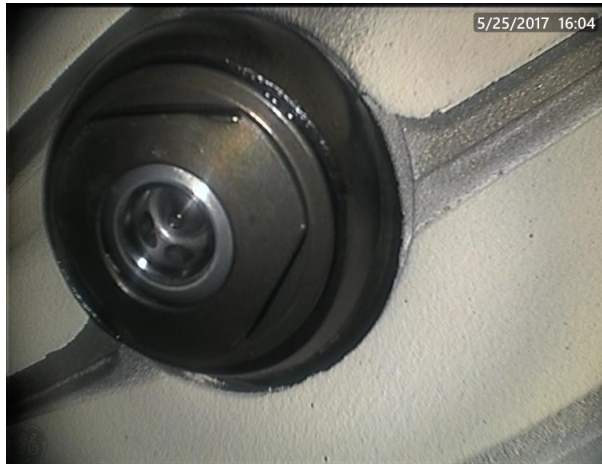
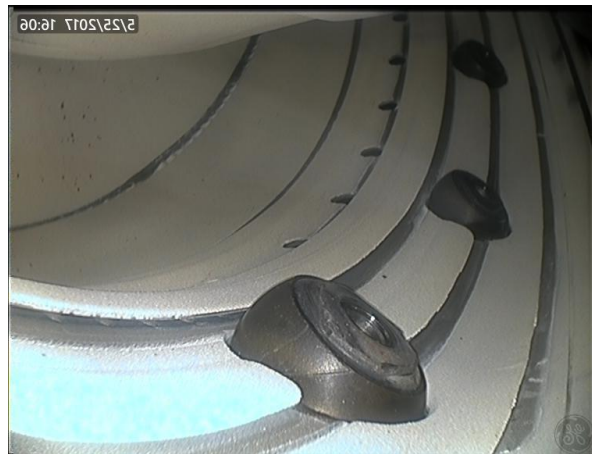
Photos 8 - Fuel nozzle condition GOOD
