## 2 General information

### 2.1 Straddle Carrier data

Crane type/model:	NSC 644 E
Serial number:	17096900-08
Year of construction:	2016
Customer:	
Location:	Kingston, Jamaica
Contact on-site:	
Date of Inspection:	April 11, 2022
Inspected by:	
Date of report:	04/14/2022
Report performed by:	
<b>Operation hours:</b>	
Diesel engine:	27318h last recorded hour reading from Display

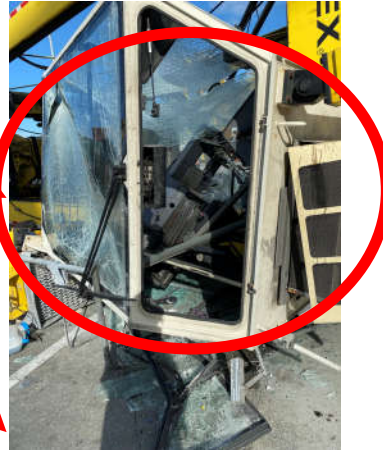
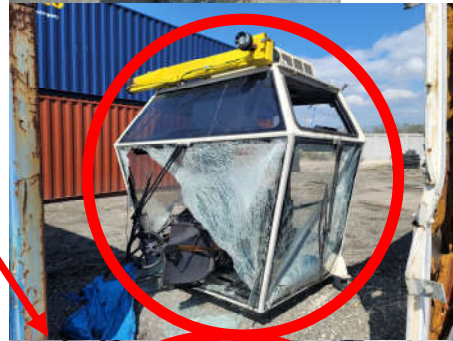
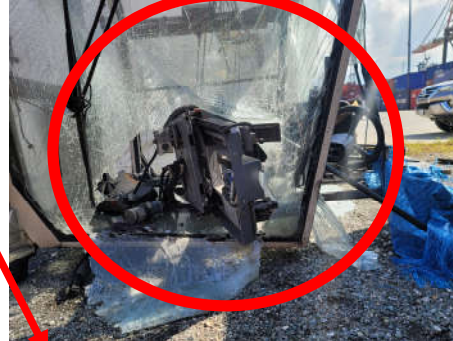
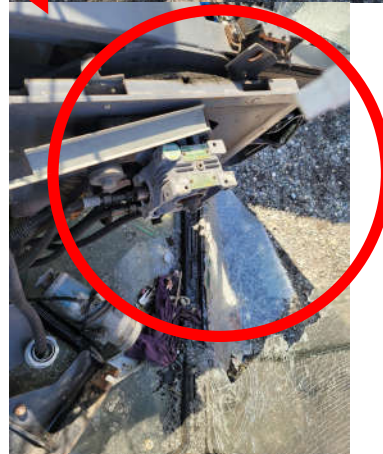
6. **Cabin:** The glass on all sides is broken; chair sheared off the mounting, as also is the frame deformed.

Cabin major damage

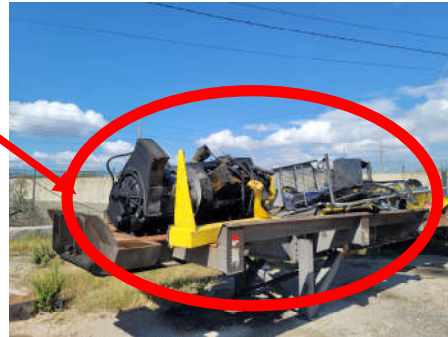
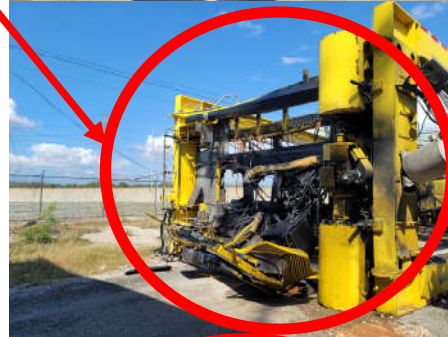
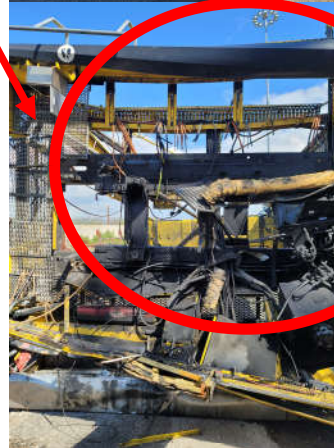
5. **Machine Platform:** There is major damage to the platform itself. However, the hoist installation shifted, SMP2 (inverter cabinet) cabinet broke off its mount and fell against the power unit, the power unit broke off its brackets, resistor banks have major deformations, SMP1 has deformations, and the platform and ladders are deformed or have major damage.

Power Unit damage (been removed from Straddle Carrier after Incident because of safety concerns at the Terminal)

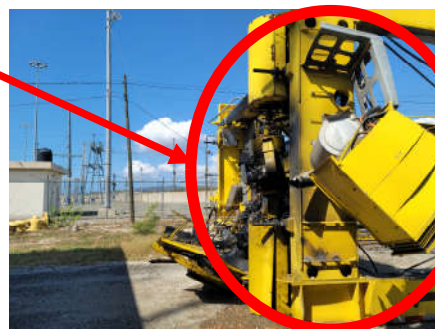
Brake Resistor Brackets damage

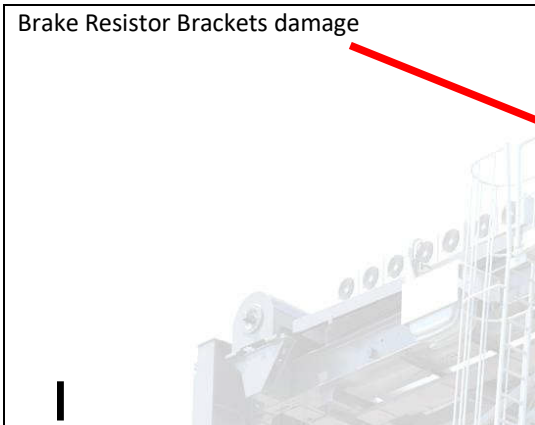
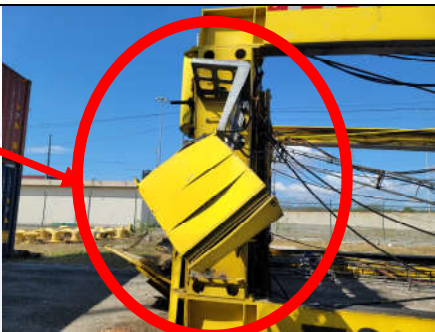
<p>Brake Resistor Brackets damage</p>

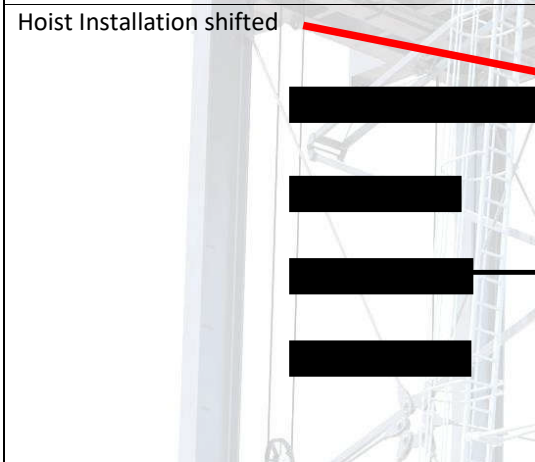
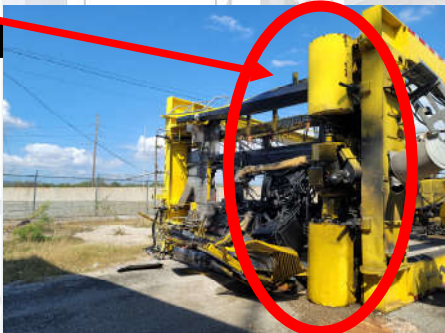
<p>Hoist Installation shifted</p>

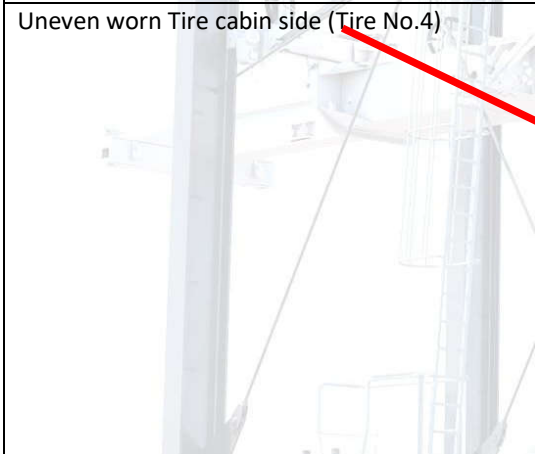
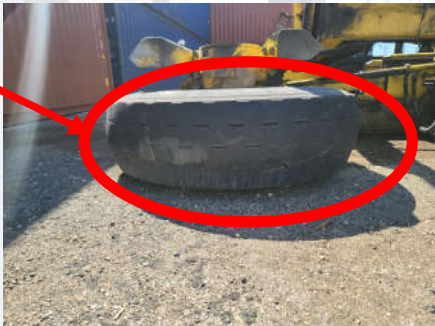
1. **Tire:** 7 Tires were in good/fair condition. Tire No.4 had a slight uneven wear. All tire pressures were correct at the time. (Tire check 04/08/2022 from KFTL available)

<p>Uneven worn Tire cabin side (Tire No.4)</p>

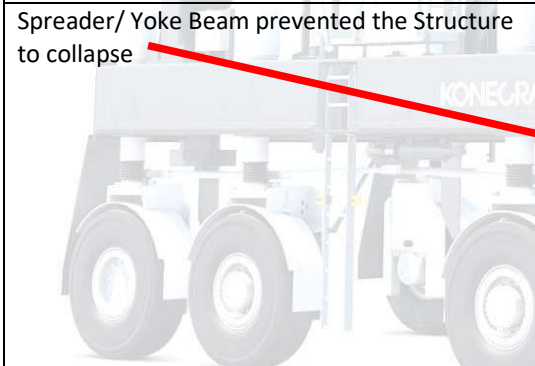
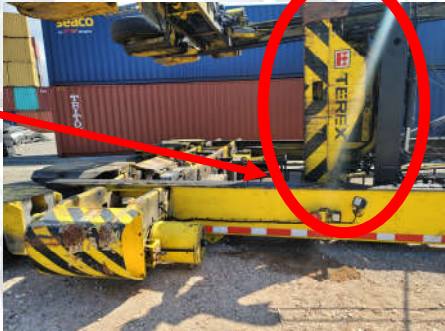
<p>Spreader/ Yoke Beam prevented the Structure to collapse</p>
